# **FIVE-YEAR REVIEW REPORT**

## **SECOND FIVE-YEAR REVIEW REPORT FOR THE FORMER DEFENSE DEPOT OGDEN OGDEN, UTAH**

**MARCH 2001**

**PREPARED BY:  
DEFENSE DISTRIBUTION DEPOT HILL UTAH  
OGDEN SITE**

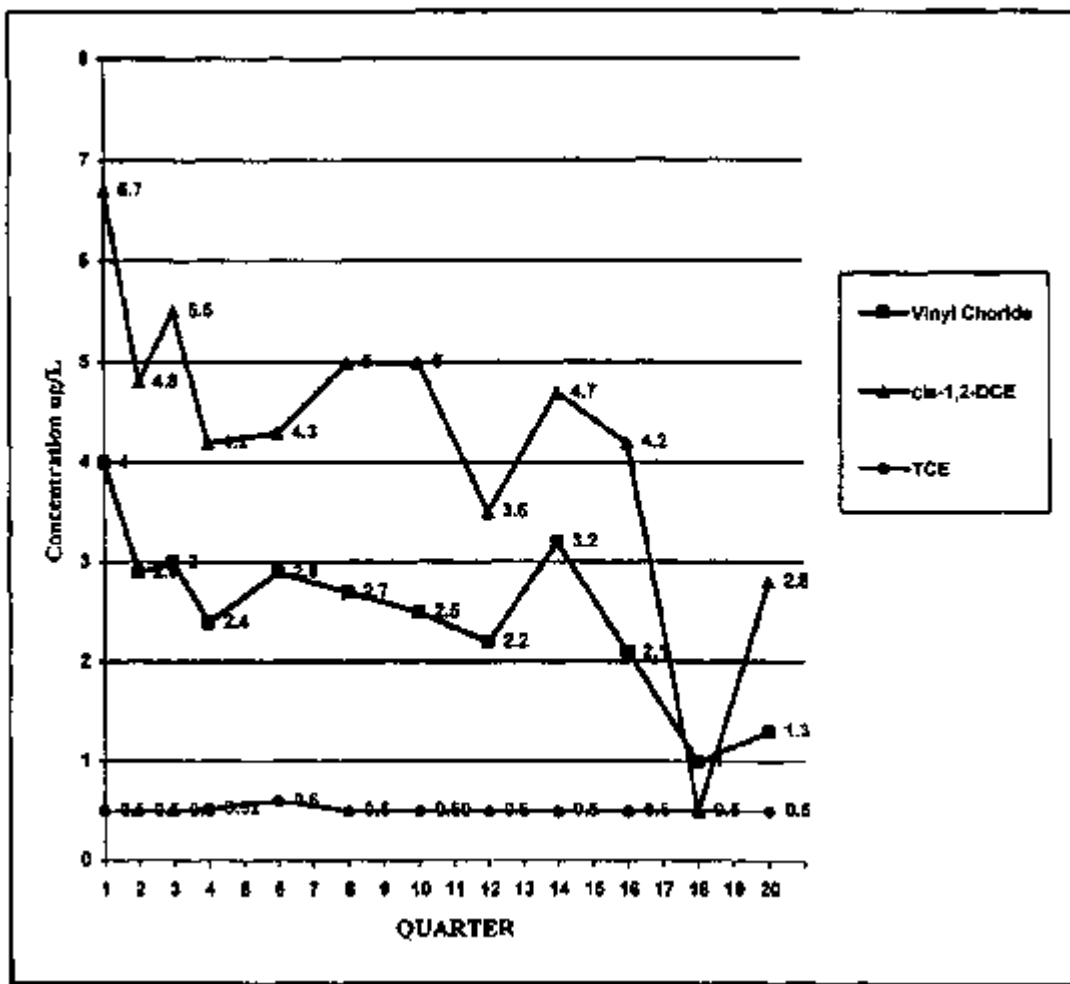
Treatment Plant Influent  
Contaminant Versus Time  
Operable Unit - 1  
Defense Depot, Hill, Utah  
July 1999

Figure 6. Plot of VOC concentration versus time for plant influent.
